TECHNICAL REPORT CERC-88-4

EFFECTIVENESS OF EXPEDIENT LEVEE-RAISING STRUCTURES

Experimental Model Investigation

Coastal Engineering Research Center

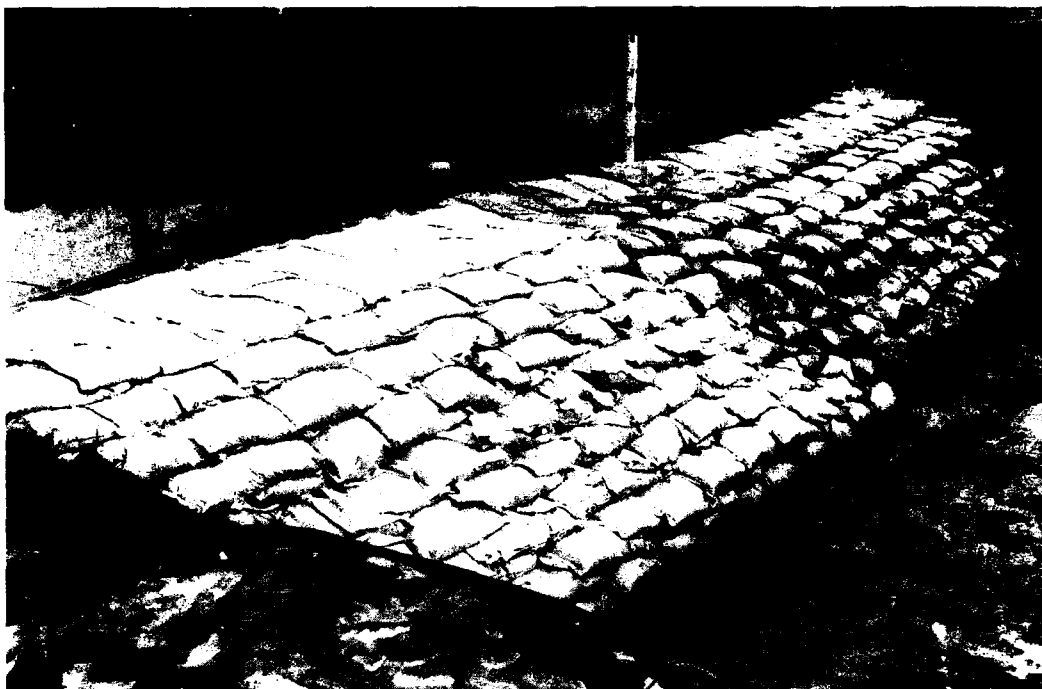
Photo 77. Landside view of Section 4-1 after 19 hr of wave action at the 1.0-ft water level

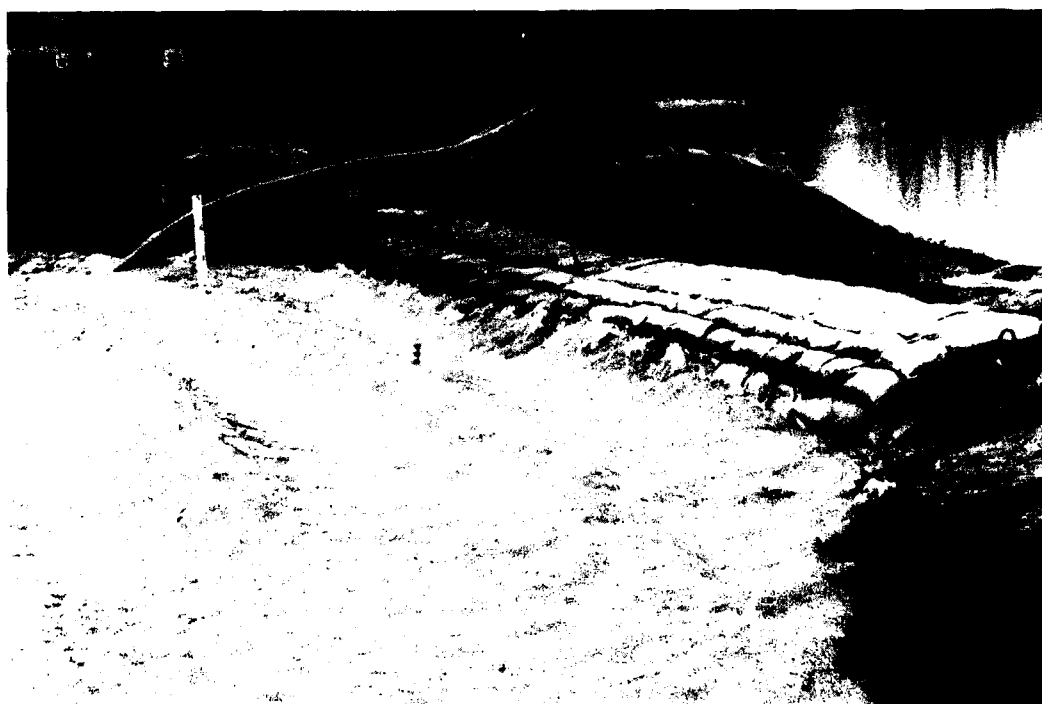
clayey silt fill appeared to be leaching out of the folded ends of the woven sacks. The structure was still in good condition, but the damage had not subsided when the wave action was stopped at the 1.0-ft depth. The test basin was flooded to the 2.0-ft depth, and Section 4-1 was exposed to 19 hr of wave attack (Photo 78) over a period of 670 hr. Considerable amounts of rain fell during this time, and, once again, the test site was flooded. At the end of wave attack at this water depth, the damage rate had become very slow. The structure had sustained considerable damage, but it still was providing good protection to the landside of the structure (Plate 18, Photos 79 and 80). The woven polypropylene and burlap sacks had continued to empty in the same manner as had been observed during wave attack at the 1.0-ft depth. The spun woven polypropylene sacks showed the highest degree of damage at this point in the test. The thread used by the manufacturer to sew the sacks together had deteriorated and broken, and this resulted in rapid emptying of several sacks (Photo 81). The structure was then exposed to 8 hr of wave action over a period of 116 hr at a 3.0-ft water depth (Photo 82). The structure sustained additional damage at this test condition but was still in relatively good condition at the end of the test (Plate 18 and Photo 83), and it could have withstood several more hours of this test condition before its stability would have become questionable. It should be noted that a large portion of the material on the lower half of the burlap sack section in Photo 83 was eroded off the existing levee and deposited in this area. Minor to moderate amounts of wave overtopping occurred at the interface of the burlap and spun woven sacks (Photo 84), but this did not cause any measurable amount of damage on the landside of the test section.

Photo 78. Riverside view of Section 4-1 during wave attack at the 2.0-ft water level

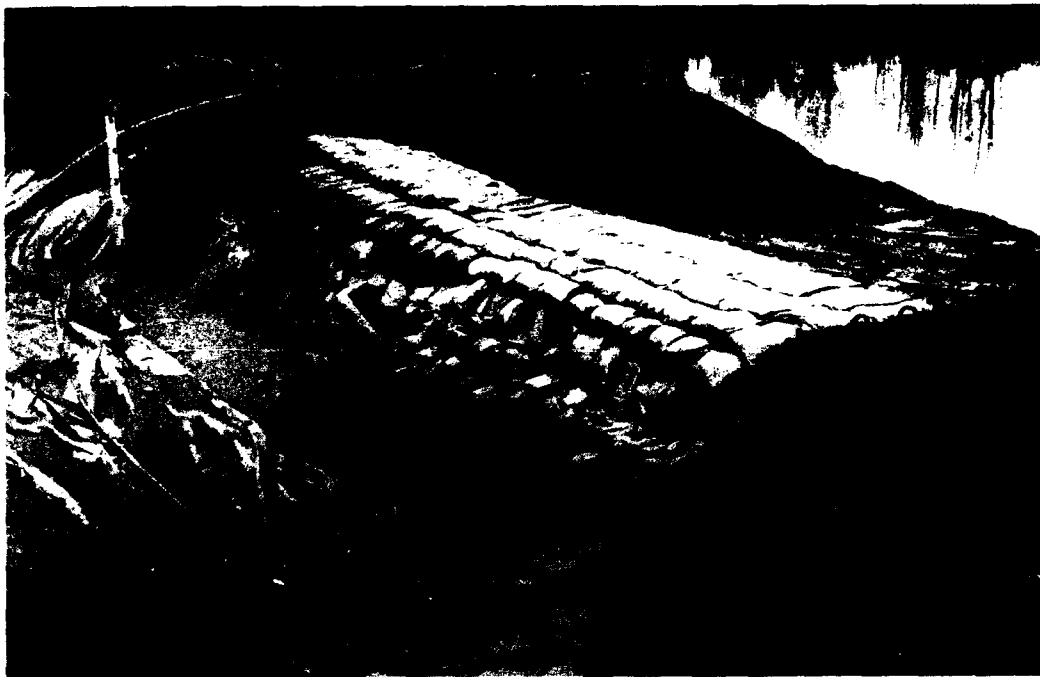
Photo 79. Riverside view of Section 4-1 after 19 hr of wave attack
at the 2.0-ft water level

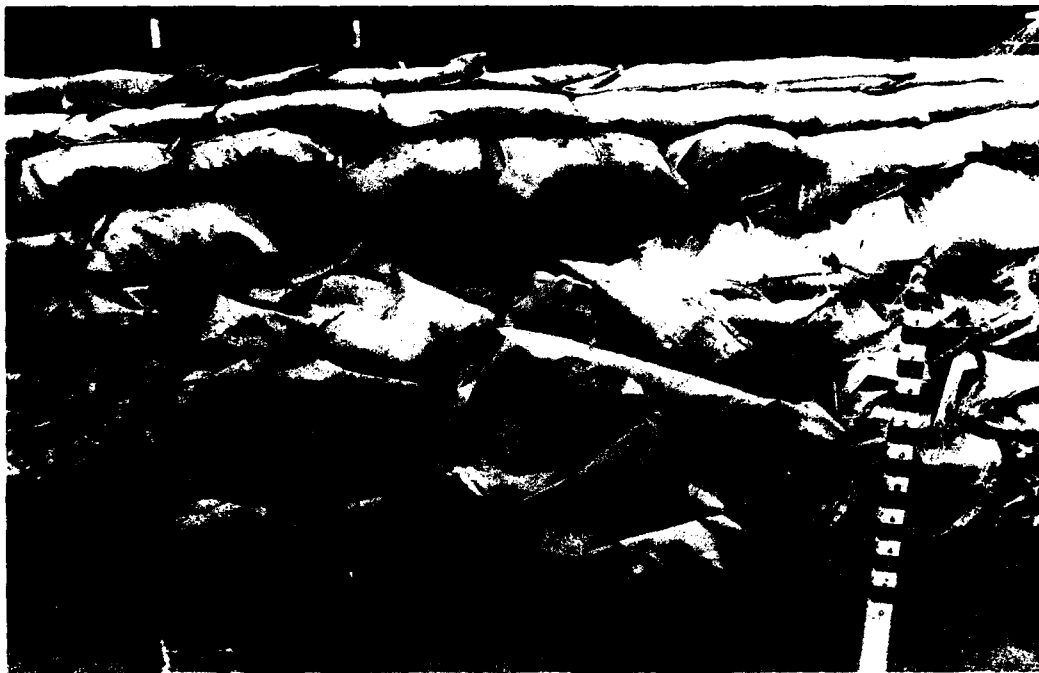
Photo 81. Riverside view of spun woven polypropylene sacks on Section 4-1 after 19 hr of wave action at the 2.0-ft water level

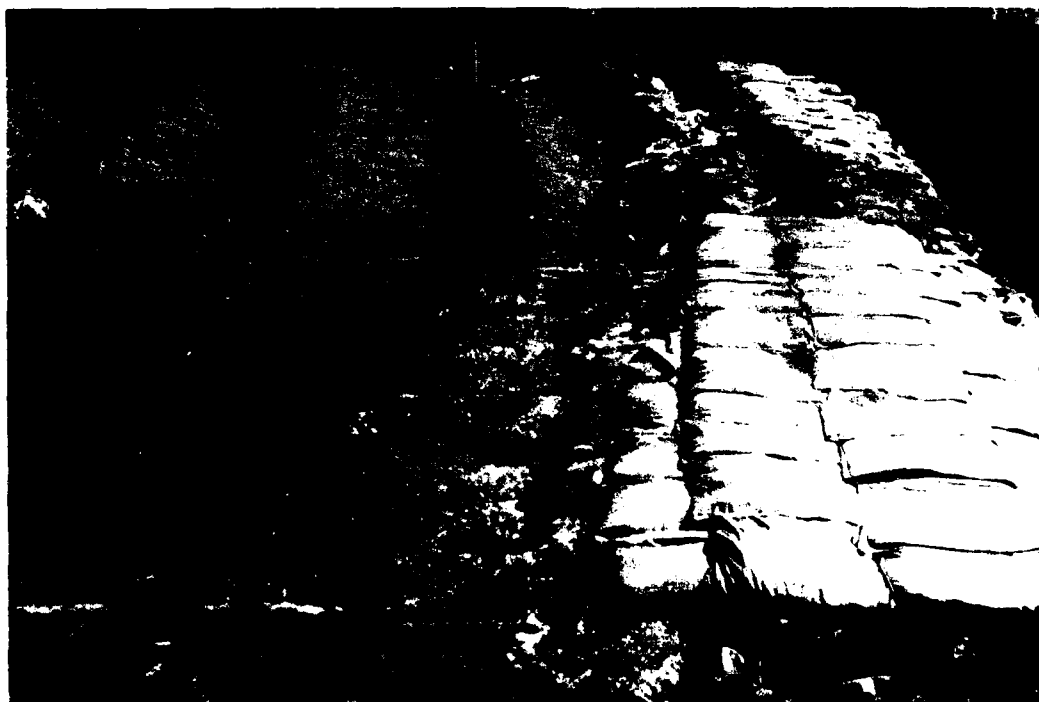
Photo 82. Riverside view of Section 4-1 during wave attack at the 3.0-ft water level

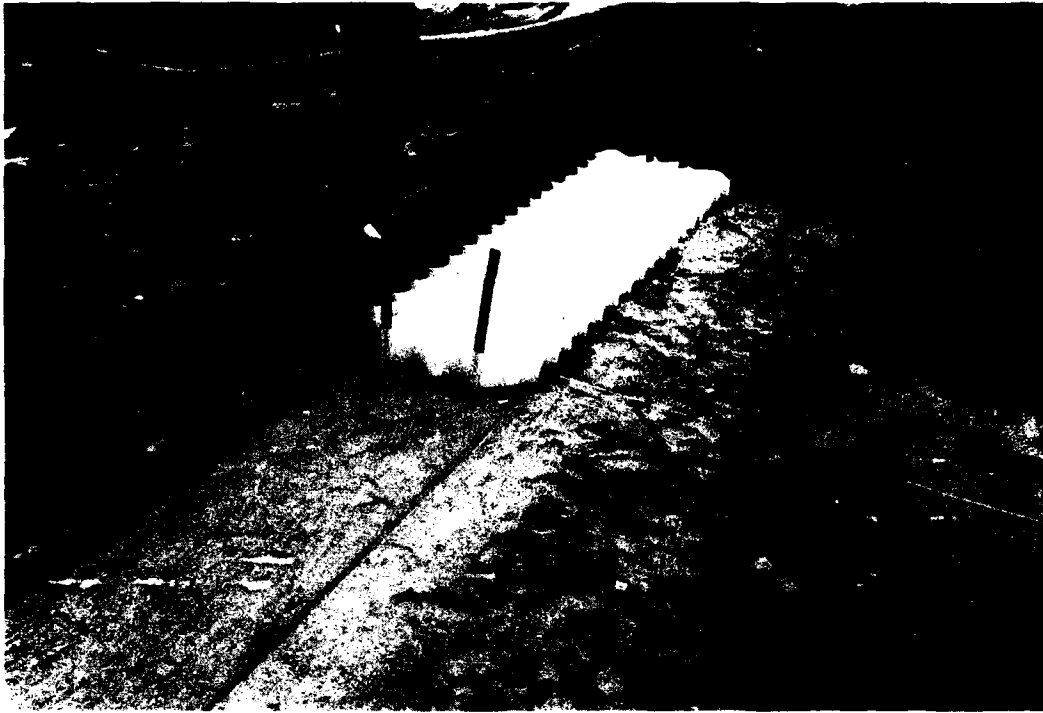
Photo 89. Expanded plastic grid in first lift of Section 4-2

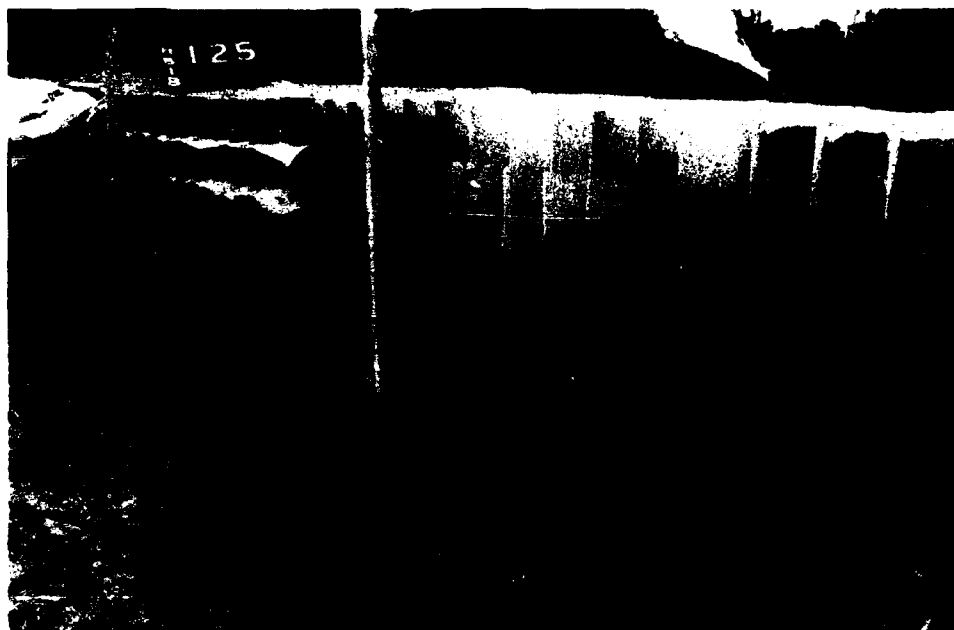
Photo 97. Riverside closeup view of the unfiltered portion of Section 4-2 at the end of the 2.0-ft static differential head

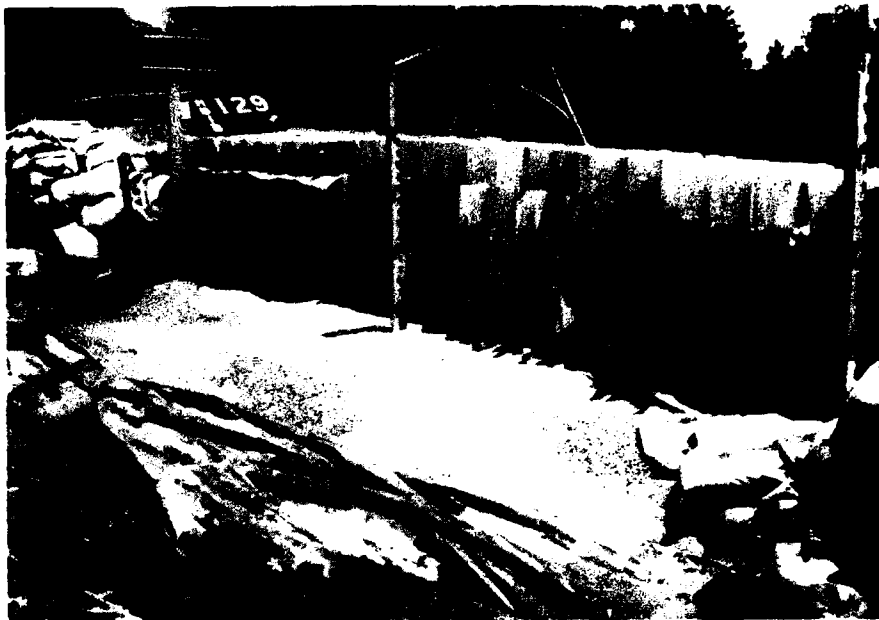
Photo 107. Riverside view of Section 4-2 after 19 hr of wave action at the 1.0-ft water level

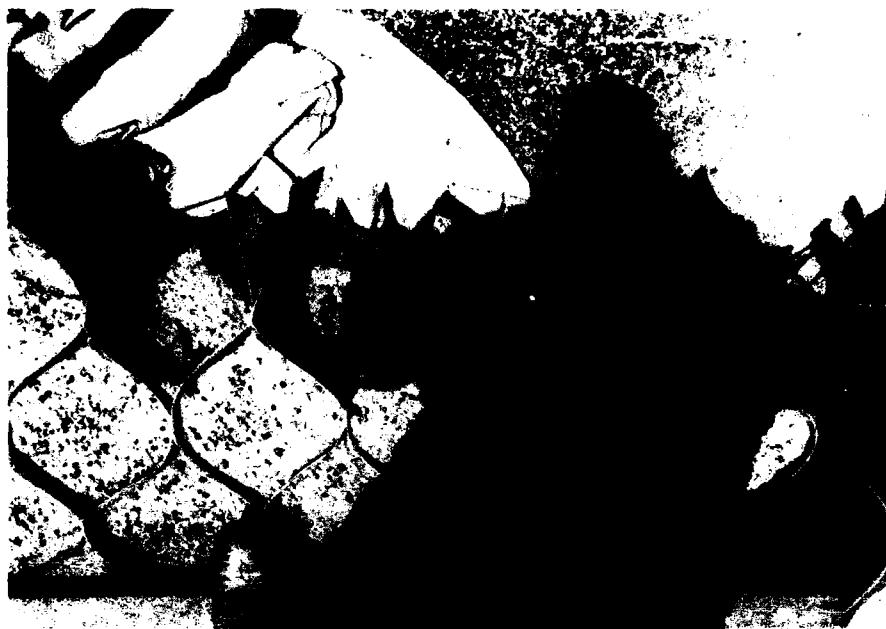
Photo 109. Closeup top view of empty cells on the river-side of the burlap filtered portion of Section 4-2 after 19 hr of wave action at the 1.0-ft water level

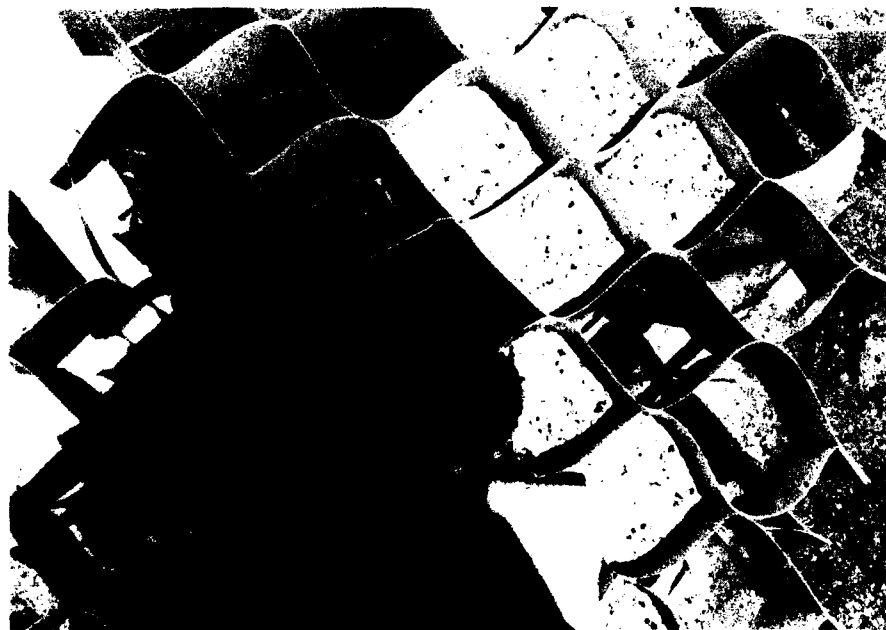
Photo 110. Closeup top view of empty cells on the unfiltered portion of Section 4-2 after 19 hr of wave action at the 1.0-ft water level

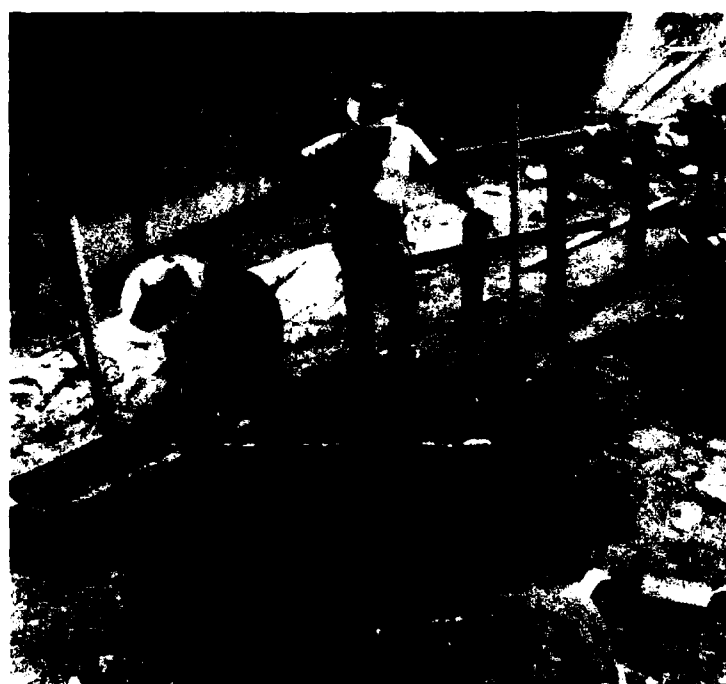
Photo 126. Installation of posts during
construction of Section 4-3

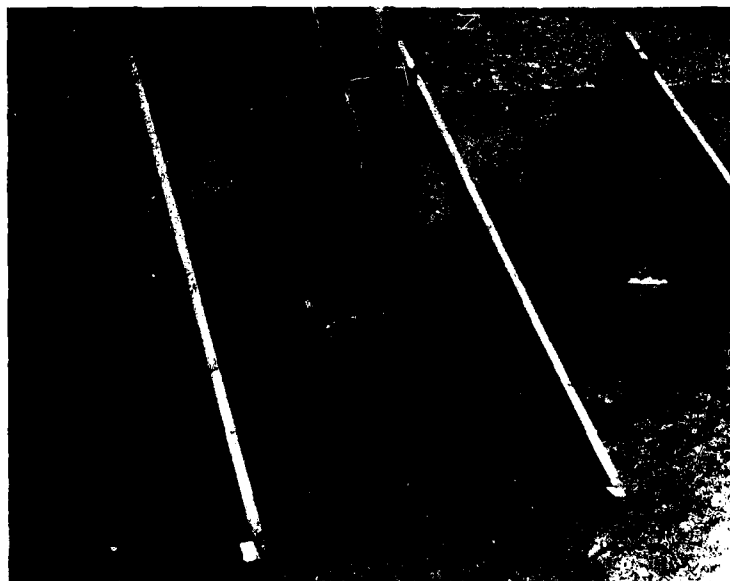
Photo 128. Landside view of Section 4-3 showing flow under Section 4-3 just prior to stopping the 1.0-ft static differential head test

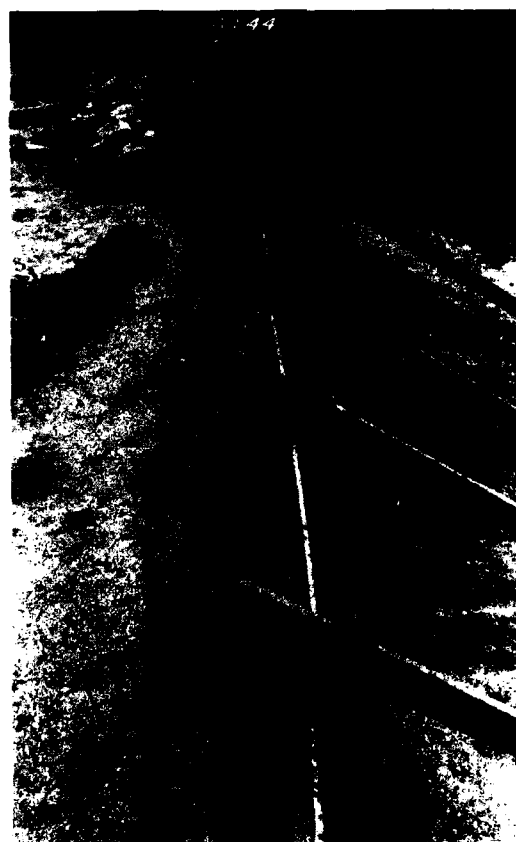
Section 4-3 (Photo 127). The 1.0-ft static differential head was left on the structure overnight. At some time during the night, the structure failed. The seepage flow had removed the trench fill material around one post and along a length of the structure that encompassed three consecutive posts. The small basin was flooded back to the 1.0-ft depth, and the filling pump was left running in order to document the flow under the structure at this 1.0-ft static differential head (Photo 128). Photographs 129-131 show the condition of Section 4-3 after its failure at the 1.0-ft static differential head.

Photo 129. Riverside view of Section 4-3 after the 1.0-ft static differential head

Photo 130. End view of Section 4-3 after the 1.0-ft static differential head

Photo 131. Landside view of Section 4-3 after the 1.0-ft static differential head

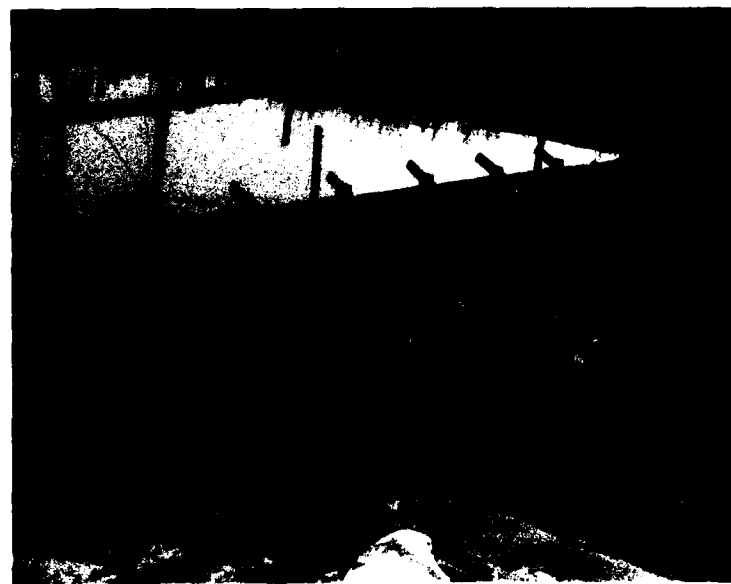
49. Section 4-3-A was exposed to 24 hr each of 1.0-, 2.0-, and 2.9-ft static differential head. The structure performed very well for all these test conditions. The only seepage occurred where the ends of the section tied into the existing levee. This area was not considered in the test, but the seepage was minimized by placing sandbags in the areas experiencing seepage. This prevented failure of the structure due to end effects that were not being considered in the test. Photographs 133 and 134 show the condition of Section 4-3-A at the end of the 2.9-ft static differential head. The water level

Photo 133. Riverside view of Section 4-3-A at the end of the static differential head tests

Photo 134. Landside view of Section 4-3-A at the end of the static differential head tests

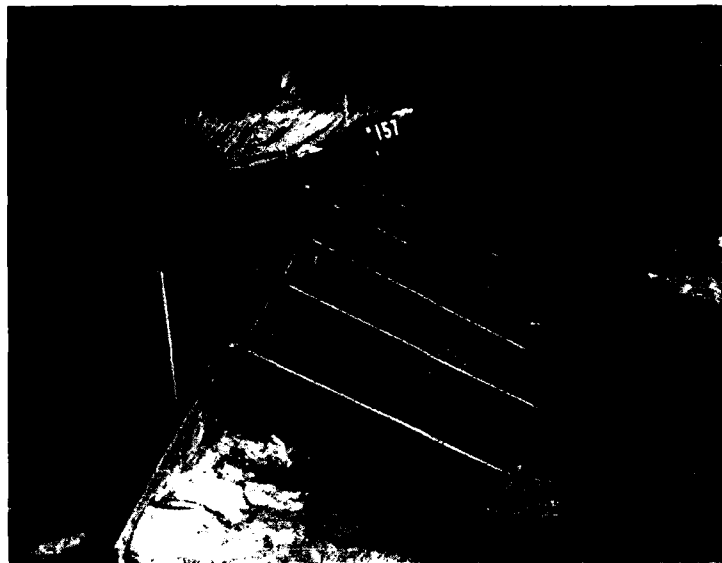
Photo 141. Landside view of Section 4-3-A after
16 hr of wave attack at the 2.5-ft water level
(end of entire test)

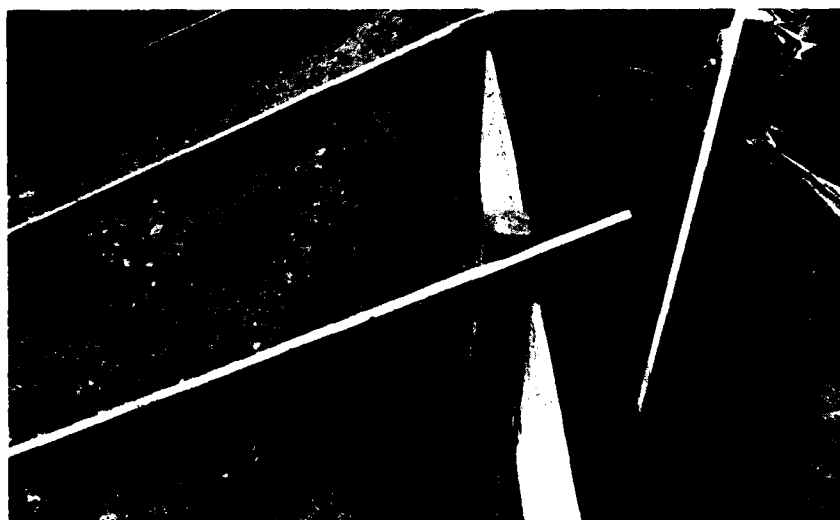
Photo 142. Close-up of Section 4-3-A showing the
erosion produced by overtopping waves at the
2.5-ft water level

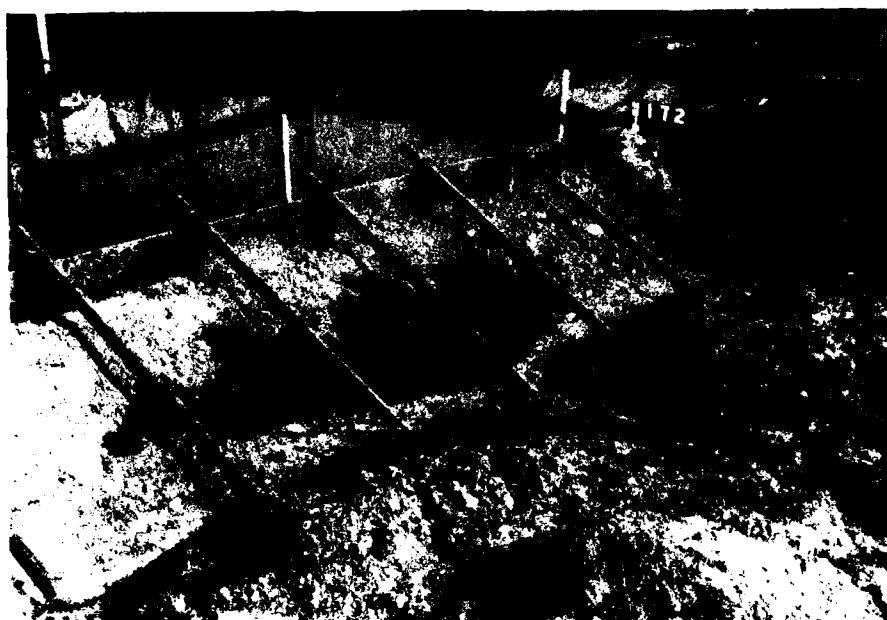
Photo 152. Landside view of Section 4-3-C at the
end of the 1.0-ft static differential head test

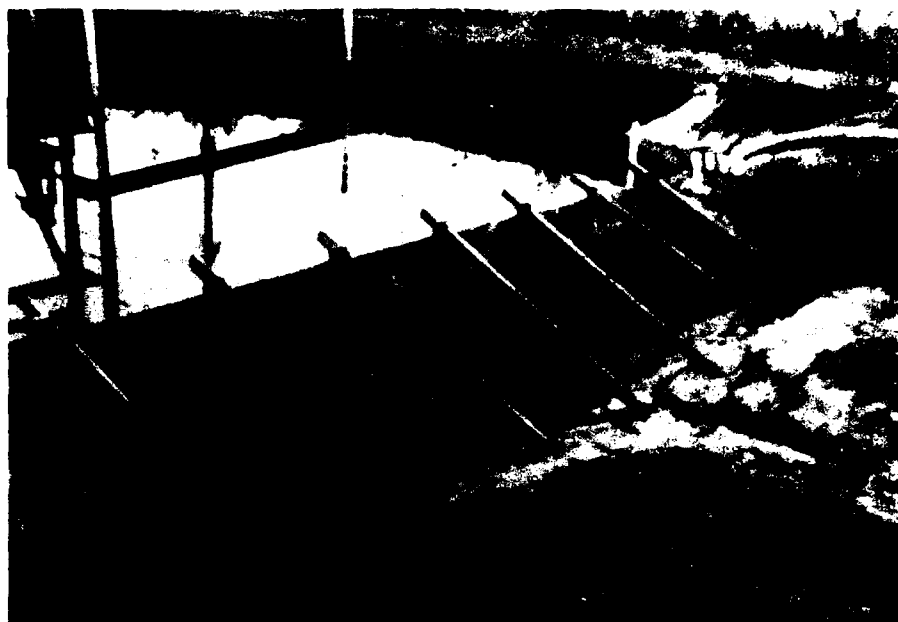
Photo 155. Landside view of Section 4-3-C at the end of the 2.0-ft static differential head test

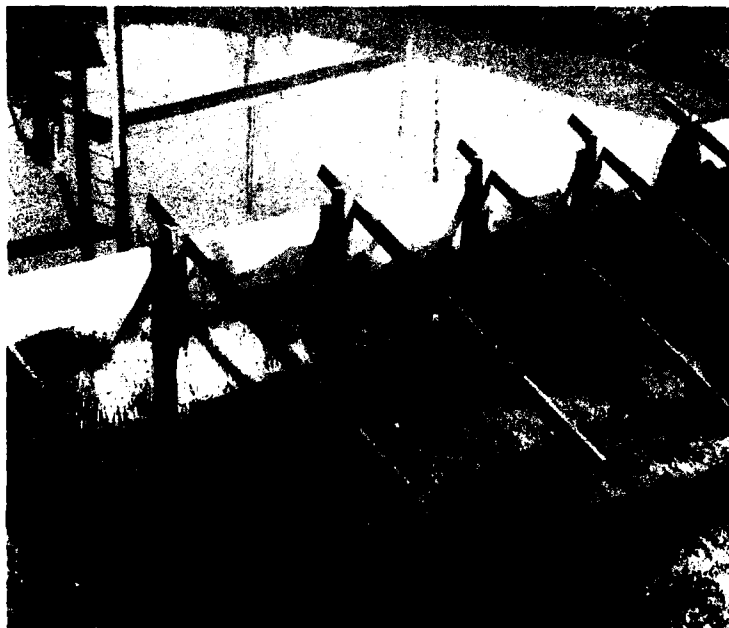
seepage could be seen exiting from beneath the asphalt; but the water was clear (Photo 170). The static head was increased to 1.5 ft and maintained for 24 hr. During this period heavy rains occurred. The seepage increased slightly, but the structure was still functioning very well (Photo 171). The static head was increased to 2.0 ft, and a slight increase in the seepage rate was noted; but the quantity of seepage was still minor. After 24 hr of 2.0-ft static head, the structure was still in good condition. However, it had become obvious that the majority of seepage was coming from around a support post. This became apparent when a prominent bulge appeared in the asphalt coating around the post (Photo 172). The seepage around this post became significant and began moving material when the static head was increased to 2.5 ft. After 2.0 hr the water broke through the asphalt and began free flowing under the plywood flashboard (Photo 173). Photo 174 shows where the asphalt coating and compacted earth-filled trench failed around one of the center support posts.

Photo 170. Landside view of Section 4-3-D at
the end of the 1.0-ft static differential
head test

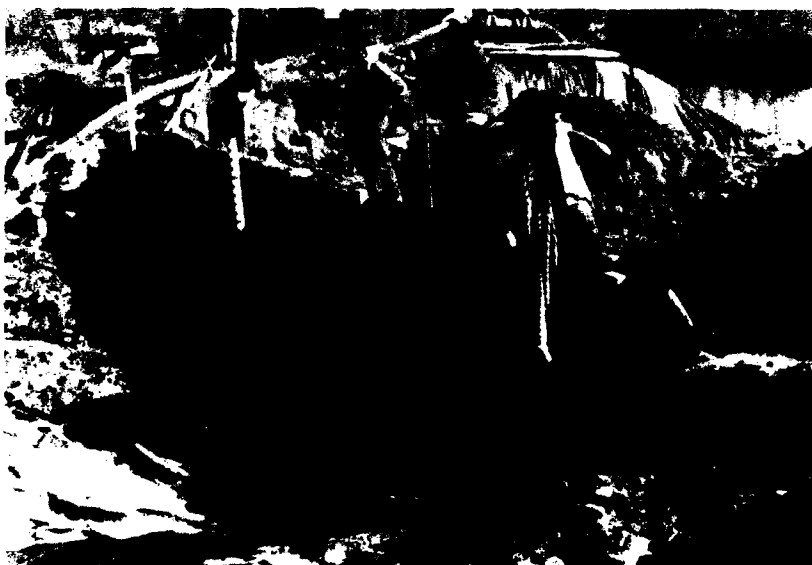
Photo 178. Riverside view of completed flashboard of Section 4-4

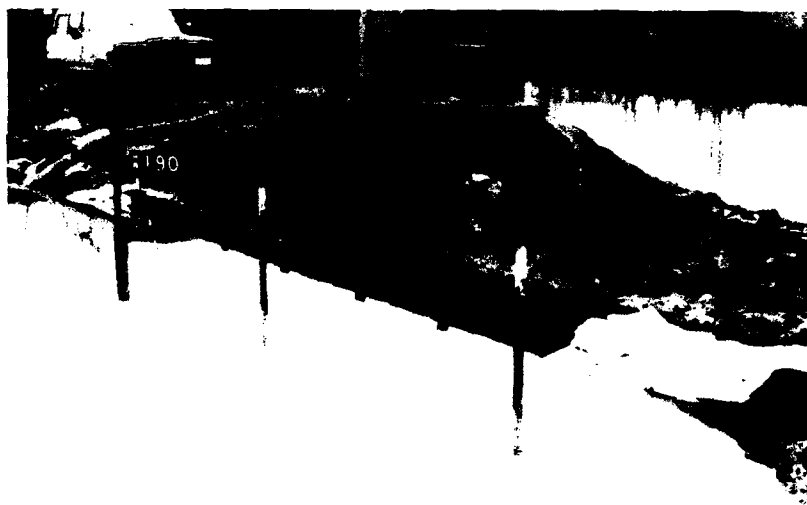
Photo 180. Riverside view of Section 4-4 at the end of the 2.5-ft static differential head test

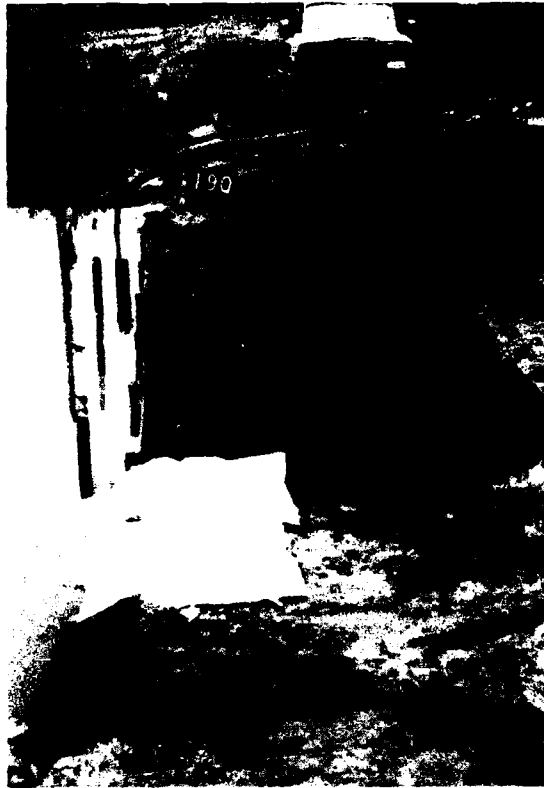
Photo 181. End view of Section 4-4
at the end of the 2.5-ft static
differential head test

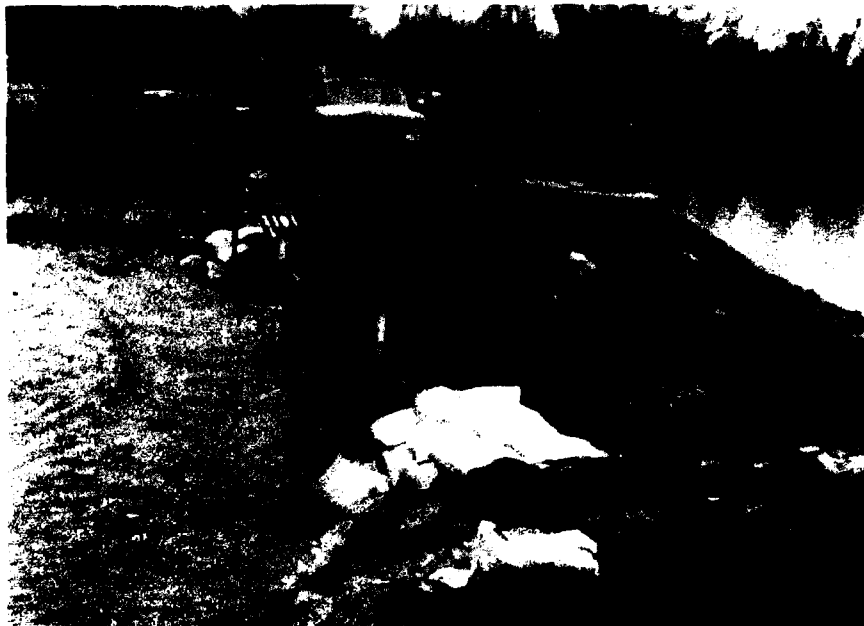
Photo 182. Section 4-4 during wave attack at the 1.0-ft
water level

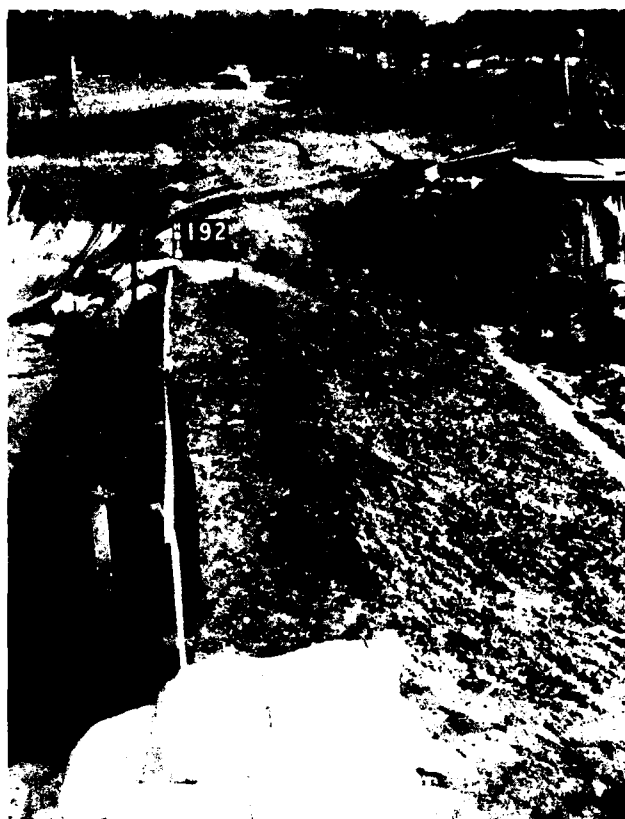
57. Section 4-4 was exposed to static differential heads of 1.0, 2.0, and 2.5 ft for periods of 24 hr each, and no measurable seepage was noted at any time. During this period, the section was exposed to 3 to 5 in. of rain which saturated the earth backing. By the end of the 2.5-ft static differential head test, the crown of the earth backing had consolidated about 2 in., and the flashboard had developed a 2- to 3-deg lean toward the riverside in some areas (Photos 180 and 181). Following the static head tests, the water level was lowered to 1.0 ft, and the structure was exposed to 19 hr of wave attack over a period of 192 hr (Photo 182). Saturation of the earth backing by heavy rains and the pumping action of the waves resulted in an increase in the riverward lean of the flashboard and additional consolidation of the earth fill. The top of the flashboard had leaned as much as 4 in. riverward in some areas. Some areas of the earth fill crown were lowered as much as 8 in. No obvious seepage was noted, and the structure was in good condition at the end of wave attack at the 1.0-ft water level (Photos 183 and 184).

Photo 183. End view of Section 4-4 after 19 hr
of wave attack at the 1.0-ft water level

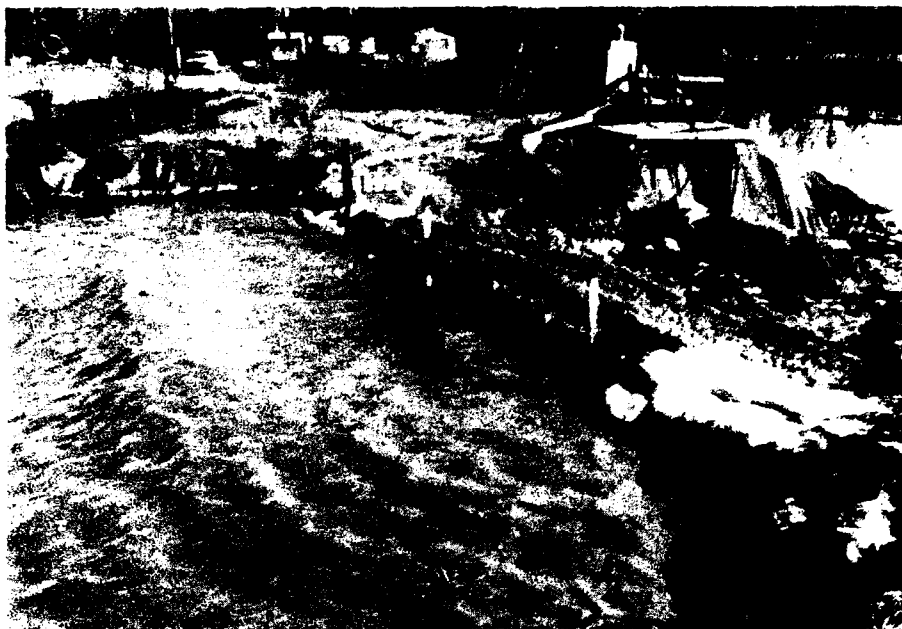
58. The water level was raised to 2.0 ft, and the structure was exposed to 8.5 hr of wave attack over a period of 48 hr (Photo 185). Some sporadic wave overtopping occurred during this test condition. The amount of overtopping water was sufficient to keep the crown of the earth backing saturated but was not enough to produce runoff and surface erosion. By the end of this test condition, the flashboard showed some additional riverward lean and earth

Photo 185. Section 4-4 during wave attack at the 2.0-ft water level

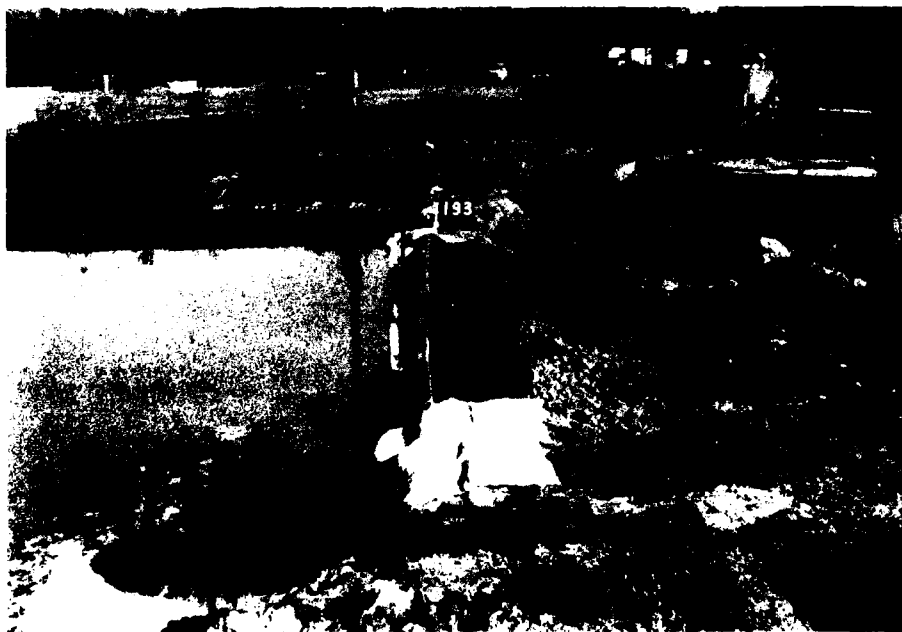
crown lowering. The test section was in good condition and did not appear to be accruing any additional damage, and no measurable seepage was observed (Photos 186 and 187). Wave attack at the 2.5-ft water level produced severe and continuous overtopping (Photo 188). The overtopping water produced very rapid erosion of the earth backing (Photos 189-192). After approximately 2.5 hr of wave attack, the structure showed major deterioration. The 6-mil poly backing had torn loose from the flashboard, and the crown and slope of the earth backing showed major erosion. When the poly tore loose, it was noted that overlap joints showed minor seepage; but scab joints showed no seepage. The pump was kept running in order to replace water being lost from the small basin by wave overtopping.

Photo 186. End view of Section 4-4 after 8.5 hr of wave attack at the 2.0-ft water level

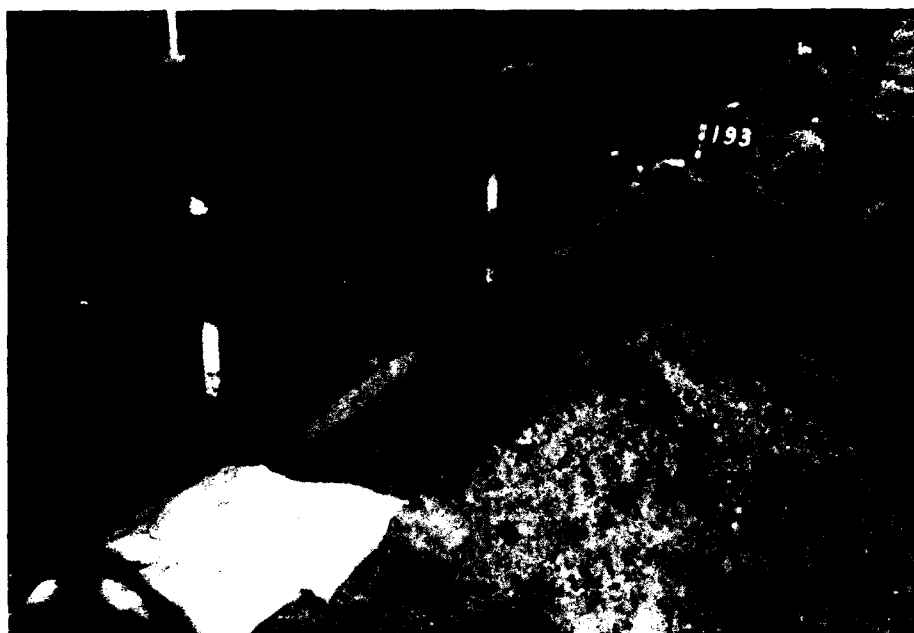
Photo 187. Landside view of Section 4-4 after 8.5 hr of wave attack at the 2.0-ft water level

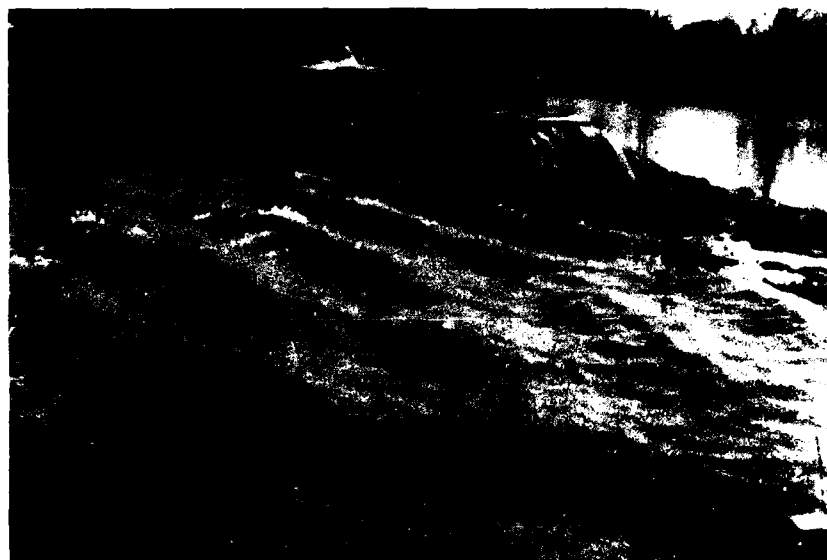
Photo 188. Section 4-4 during wave attack at the 2.5-ft water level

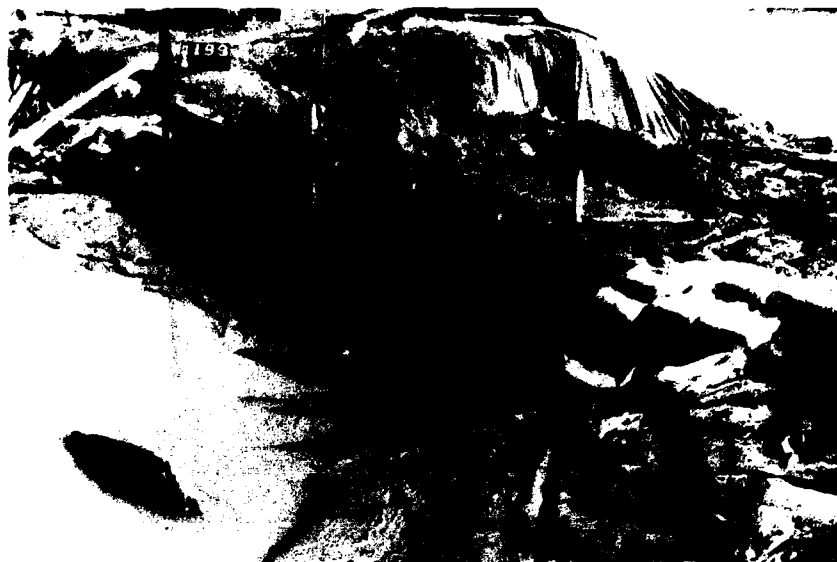
59. When the wave machine was stopped, water loss from the small basin also stopped, indicating no major seepage or boils had formed. The flashboard showed continuous flexure with each impinging wave, and this movement increased as the earth backing was lost (Photo 193). After 3.0 hr of wave attack, a boil formed (Photo 194), and water loss from the small basin became so rapid that even with the wave machine turned off (wave overtopping stopped) the pump could not maintain the 2.5-ft water level. The pump was turned off, and the small basin was allowed to drain through the failed area of the test section. Photos 195-198 show the condition of Section 4-4 at the end of the entire test.

Photo 195. Riverside view of Section 4-4 at
end of test

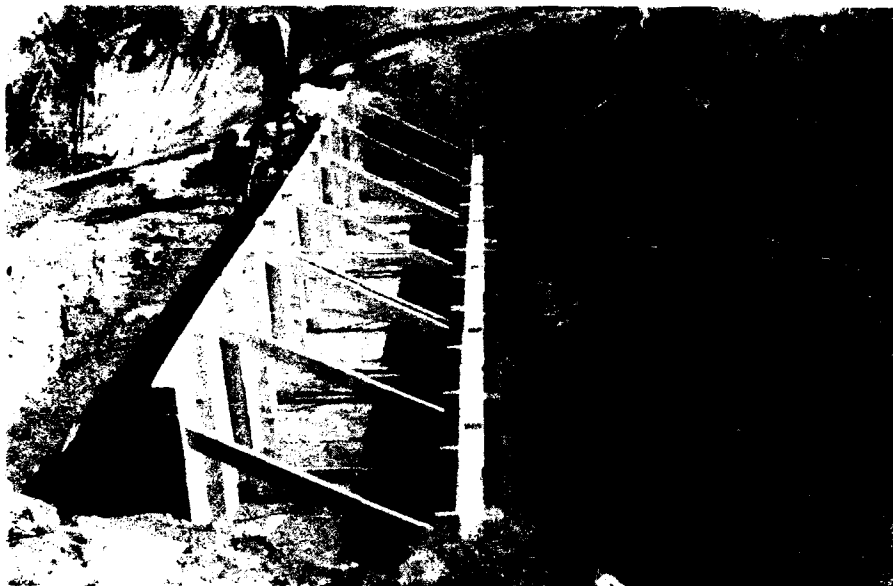
Photo 201. Side view of Section 4-5 showing completed mud boxes prior to placing fill

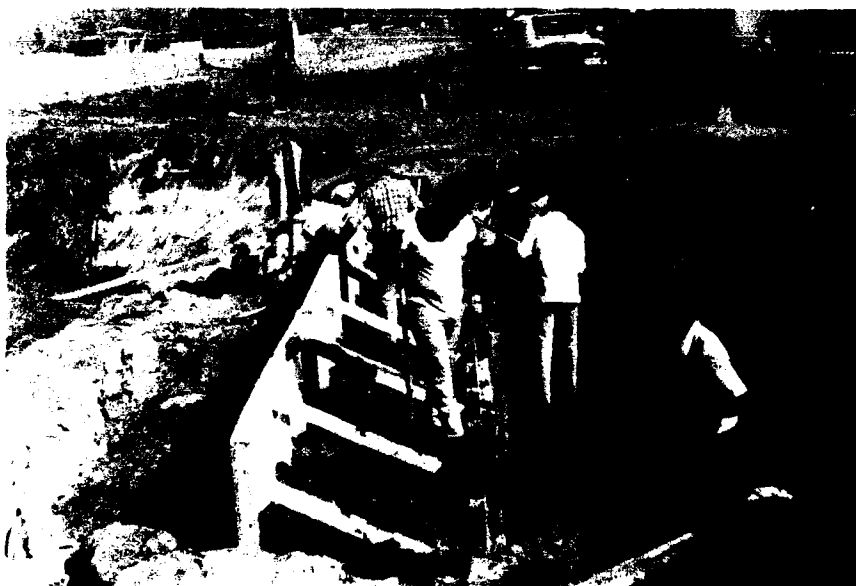
Photo 202. Side view of Section 4-5 during placement of fill

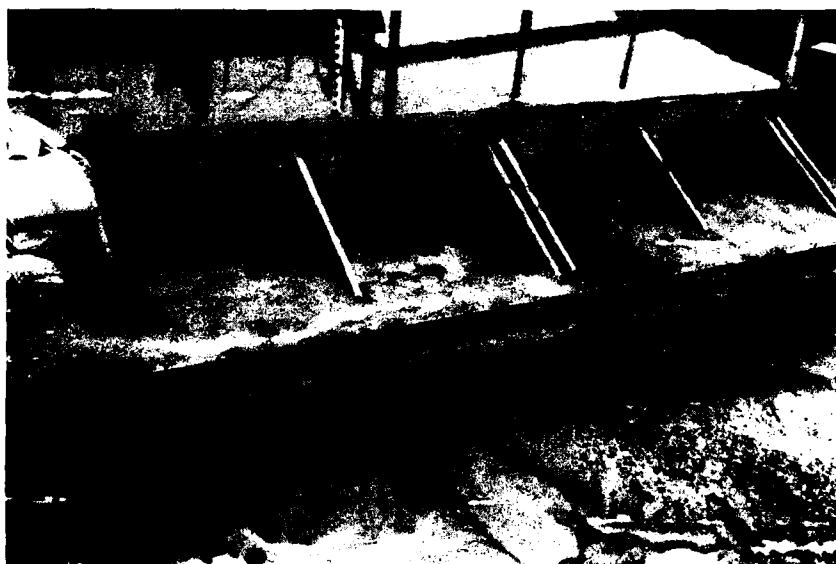
Photo 210. Landside view of Section 4-5 at the end of the 2.5-ft static differential head test

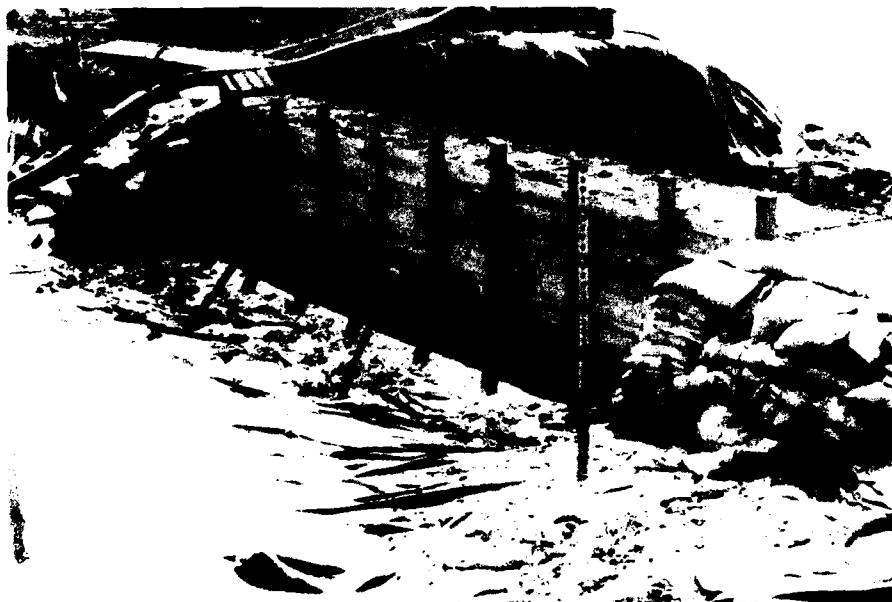
66. Section 4-6. Section 4-6 (Plate 28 and Photos 214 and 215) was a 4-ft-high planking mud box with tamped earth fill. The test section was constructed following the guidelines described in the preceding paragraph. Photos 216-218 show Section 4-6 during various construction phases. The structure was exposed to static differential heads of 1.0, 2.0, 3.0, and 3.5 ft for periods of 24, 72, 24, and 24 hr, respectively. The structure showed no instability or seepage for any of the test conditions. Photos 219 and 220 show the test section at the end of the 3.5-ft static differential head. Following the static differential head tests, the small basin water level was lowered to a 1.0-ft depth, and the structure was exposed to 19 hr of wave action over a period of 168 hr. The test section then was exposed to 4.5 hr of wave action at the 2.0-ft water level over a period of 48 hr. During these two wave and swl conditions, the structure sustained no damage. Wave action at the 3.0-ft water level produced moderate to significant overtopping which kept water ponded on the earth fill (Photos 221 and 222). After 9 hr of wave action at the 3.0-ft level over a period of 96 hr, the earth fill had been lost in one area. With the water ponded on top of the fill, piping of water down through the earth fill and out the landside toe of the structure had caused this material loss. The structure could have been repaired quite easily, but this condition showed that the structure is susceptible to damage once a wave and swl combination is reached that causes wave overtopping (Photos 223-225).

Photo 214. Riverside view of Section 4-6 before testing

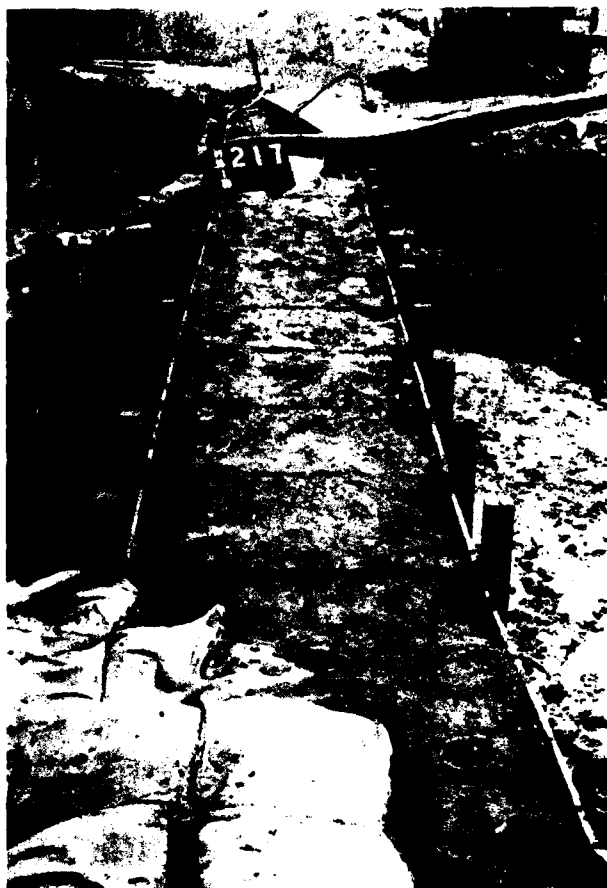
Photo 215. Side view of Section 4-6
before testing

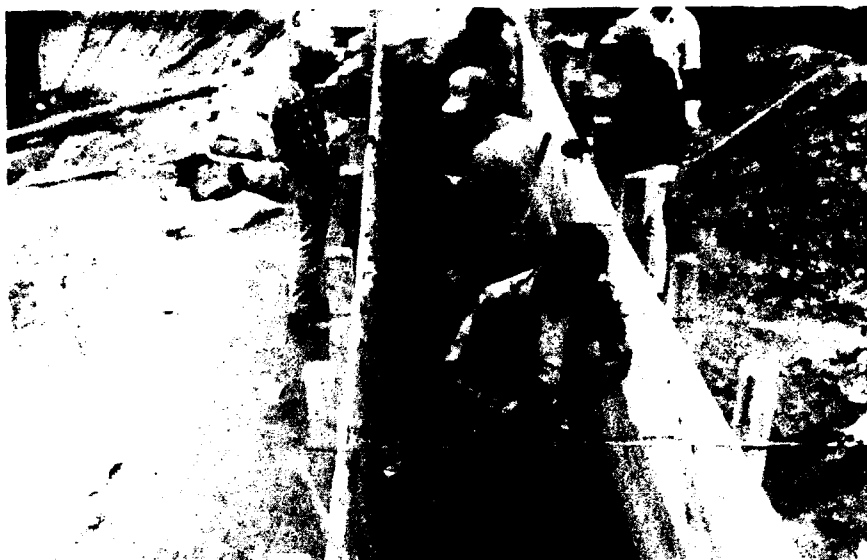
Photo 217. Side view of Section 4-6 during placement of wire ties

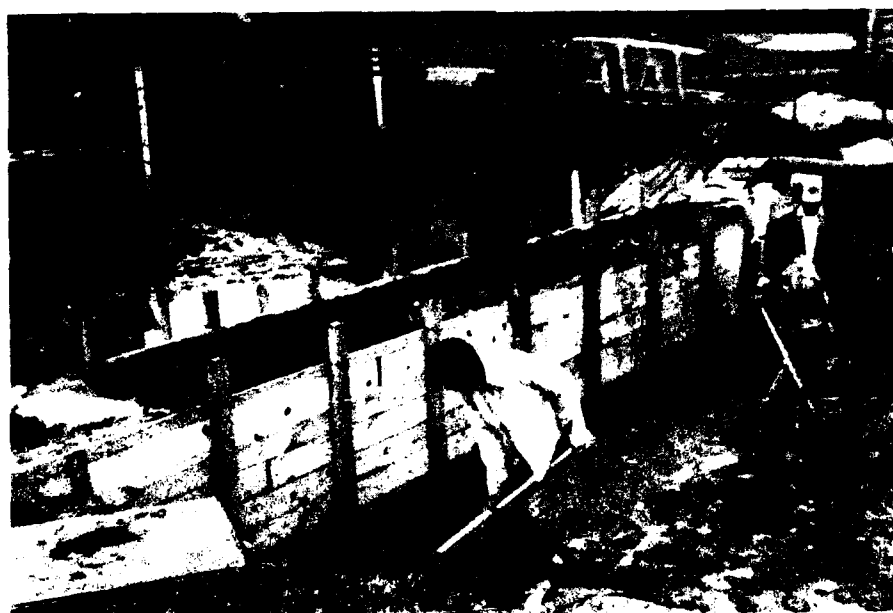
Photo 218. Landside view of Section 4-6 during placement of tamped earth fill
